Spatial Variability of Saturated Hydraulic Conductivity and Thresholds for Slope Failure at  
Sedgwick Ranch, California

A Thesis submitted in partial satisfaction of the  
requirements for the degree Master of Science  
in Earth Science

September 2016

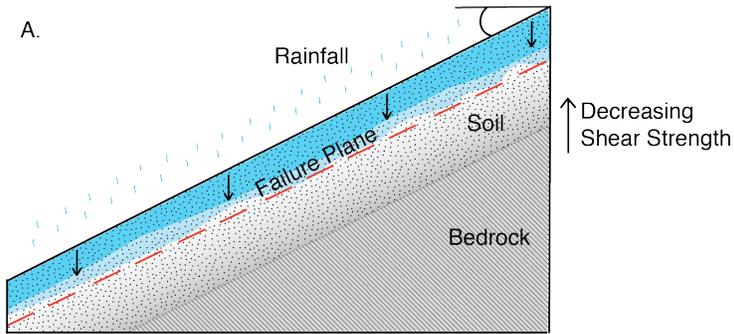
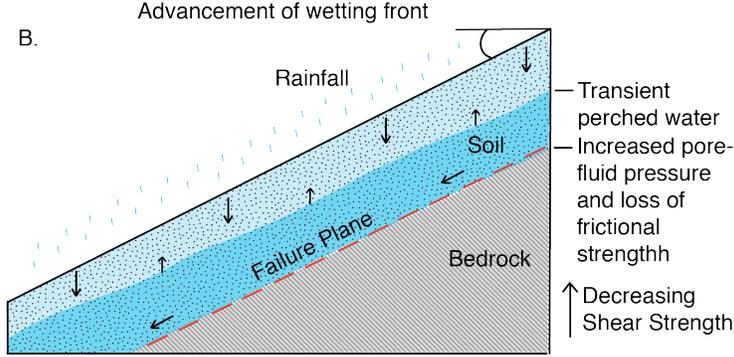
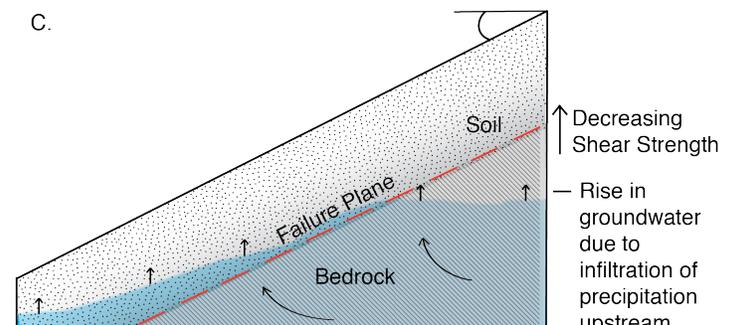
**Figure 1: A conceptual cross section of a hillslope, portraying conditions that may lead to debris flow initiation. 1A) The advancement of the wetting front. 1B) Buildup of pore fluid pressure on a low-conductivity layer. 1C) Exfiltration of groundwater through bedrock. The dark grey layer at the bottom represents bedrock, and lighter shades represent soils with decreasing shear strength. The red dashed lines refer to potential failure planes. Black arrows are potential flow paths of water, either from the unsaturated zone (top) or groundwater (bottom).**

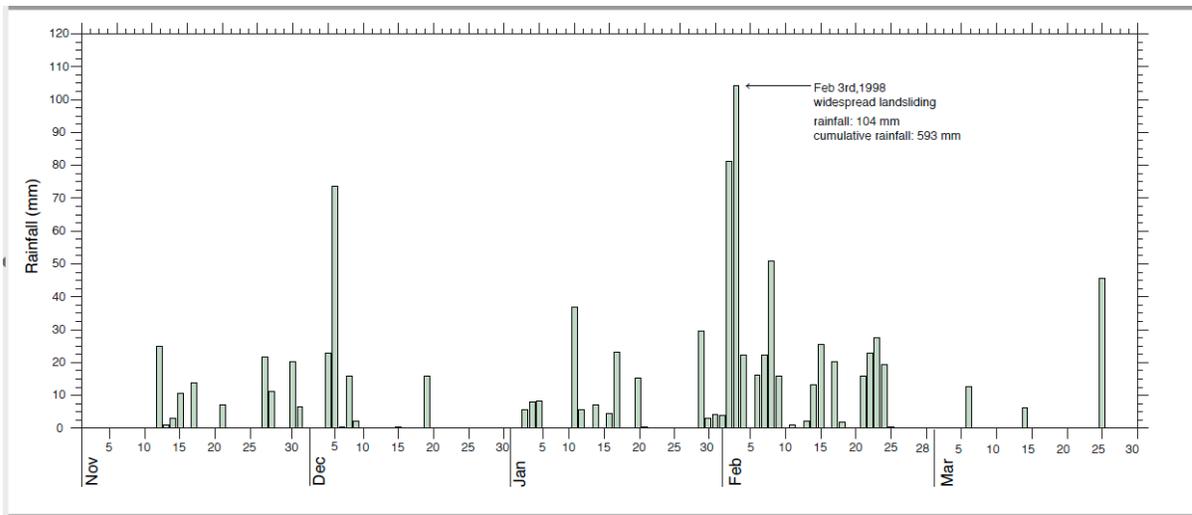
**Figure 4: Daily rainfall totals from the Figueroa Mountain Ranger Station (3 km NE of Sedgwick Reserve). Landsliding occurred on Feb 3<sup>rd</sup>, 1998. Data acquired from NOAA.**

The nearest rain gauge to Sedgwick Reserve that recorded the 1997-98' event is located at Figueroa Mountain Station, 4.5 km from the study site. Average rainfall at this station over the last 30 years is 544 mm/yr, and during 1997-98, 1164 mm of rain was recorded (Figure 4). Rainfall at this station is recorded in 24 hour intervals. The largest storm occurred on February, 3, 1998, dropping 104 mm of rain. Unfortunately, intensity-duration data from this particular station are missing for the 1997-1998 events. The nearest rain gauge that recorded rainfall intensities during 1997-98' is located in Foxen Canyon, 9.5 km away from the study area. Average and maximum rainfall intensities at various time intervals for Foxen Canyon correspond with a recurrence interval of 10-25 years for this area.

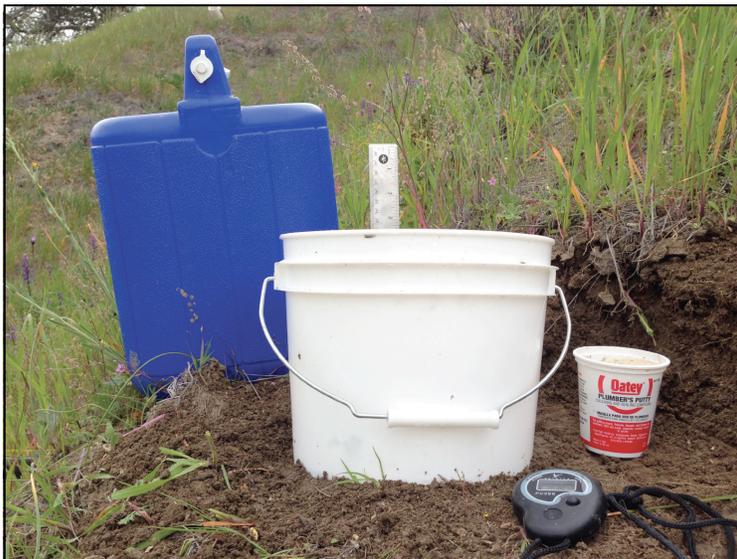
**Figure 5: The falling-head single-ring infiltrometer, or bottomless bucket, used to make  $K_{sat}$  measurements. Plumber's putty was used to seal the outer edges to prevent leakage. A ruler was attached to the side to measure the rate of infiltration.**

Implementation of the procedure includes a vertical-sided bottomless bucket, small shovel, a stopwatch, ruler, and several liters of water (Figure 5). The bucket used in the study is 20 cm high, and has a diameter of 24 cm at the top and bottom. A ruler was attached to the side of the bucket with a clip to measure the amount of infiltrated water.

Tests were performed on a vertical section of the lateral scarp (the area next to the landslide that didn’t fail). A small area atop the scarp was first cleared of vegetation and leveled. Next, a vertical section was cleaned off and soil descriptions were made. A measurement of  $K_{sat}$  was then performed on the exhumed horizontal surface. A soil sample was then taken directly from the same area for grain size analysis and bulk density

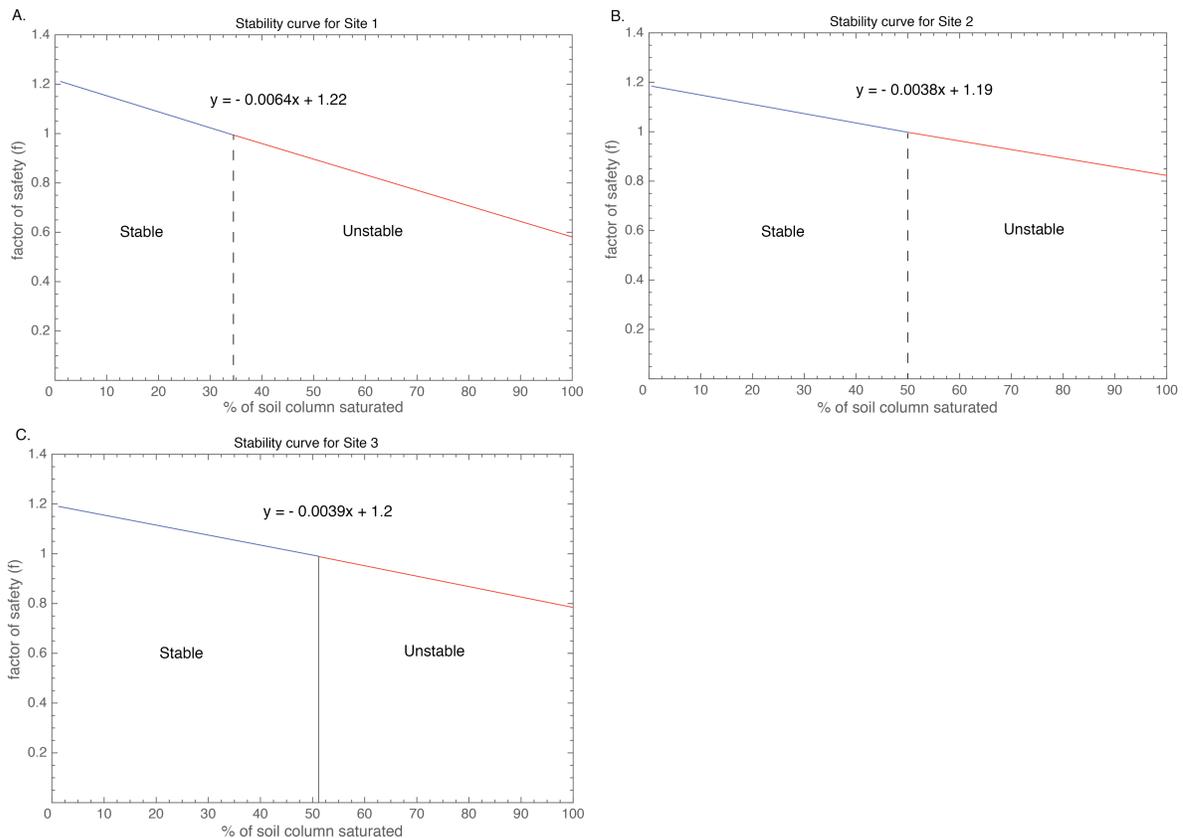
**Figure 6: A) stability curve for site 1; B) stability curve for site 2; C) stability curve for site 3. At  $m = 0$ , the hillslope is stable, and as  $m$  increases,  $f$  monotonically declines, until  $f < 1$  and failure occurs.**

After applying equation 4, each site had certain characteristics in common but each exhibited a unique failure condition. All sites were stable during dry conditions, at  $f > 1$ , and became unstable, at  $f < 1$ , when the soil column was wetted somewhere between 30-50 % of saturation. This is shown graphically for each site in Figure 6. The analysis also indicates that the coastal sage hillslope was most stable when compared to either of the grassland sites. Site 1 failed at 34% of soil column saturation, site 2 failed at 54%, and site 3 failed at 50%.

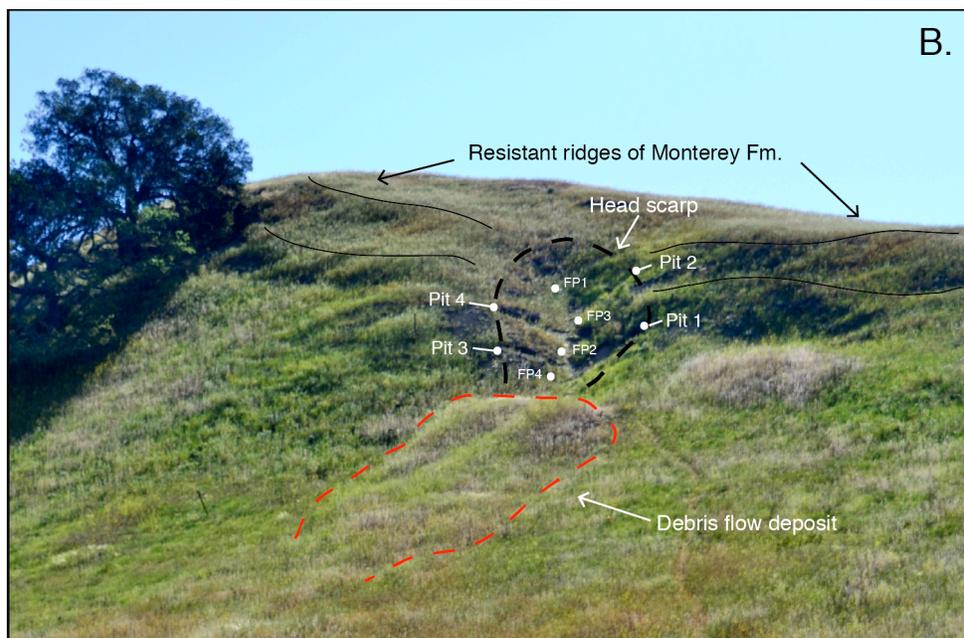
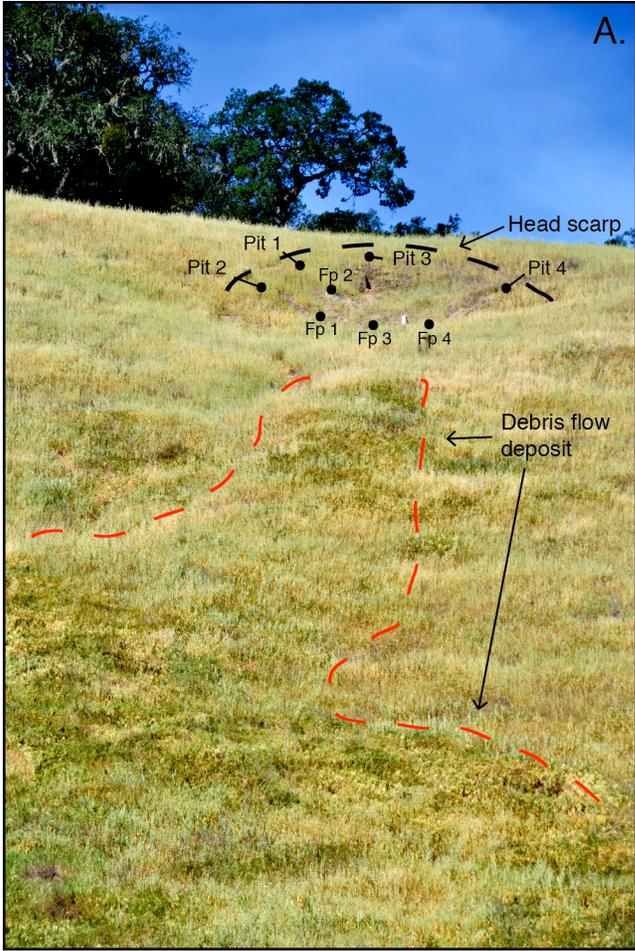
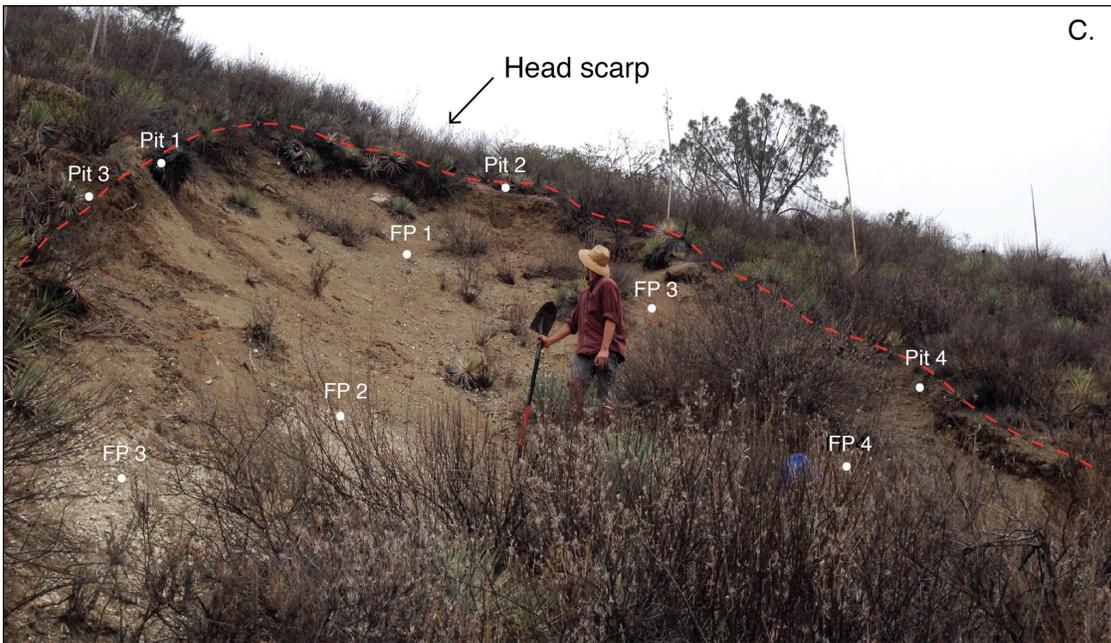
**Figure 7: Infiltration measurements and pit locations are marked for each site. A dashed black line delineates the head scarp of the debris flow and red dashed lines outline the deposit. A) site 1 B) site 2 C) site 3.**

Failure morphology and locations of measurements for site 1 are shown in Figure 7a. The underlying bedrock at site 1 is Paso Robles formation and the vegetation cover is predominately Mediterranean grasses. Site 1 is situated in a colluvial hollow, where the underlying Paso Robles Fm. forms a “u” shape that begins at the lateral scarps and meets in the center of the slide. This section of the hillslope is an unchanneled portion of the hillslope

Figure 7b displays the morphology of site 2 and the locations of infiltration measurements. The underlying bedrock at this site is the Monterey Formation and the vegetation cover consists predominately of Mediterranean grasses. Similar to site 1, site 2 is also situated in a hollow, where the bedrock was found to be “u” shaped, and converges at the deepest part in the center of the slide. Resistant ridges of Monterey formation flank both sides of the hollow, as seen in figure 7b. Failure occurred near the upper-middle portion of the hillslope at the concave-convex transition. The soil mantle consists of a 20 to 35 cm A horizon, followed by a 10 to 20 cm AC horizon (Figure 8b).

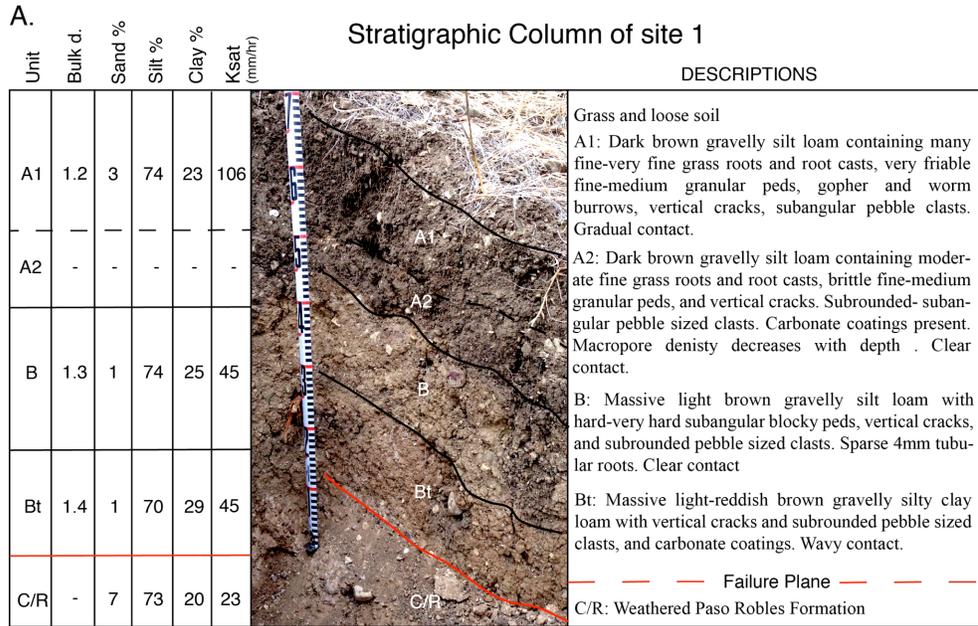
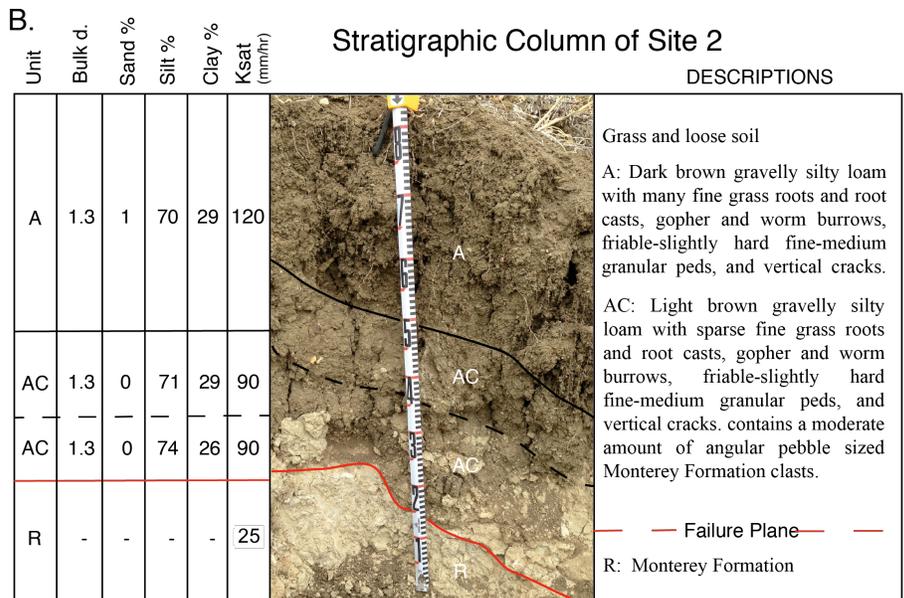
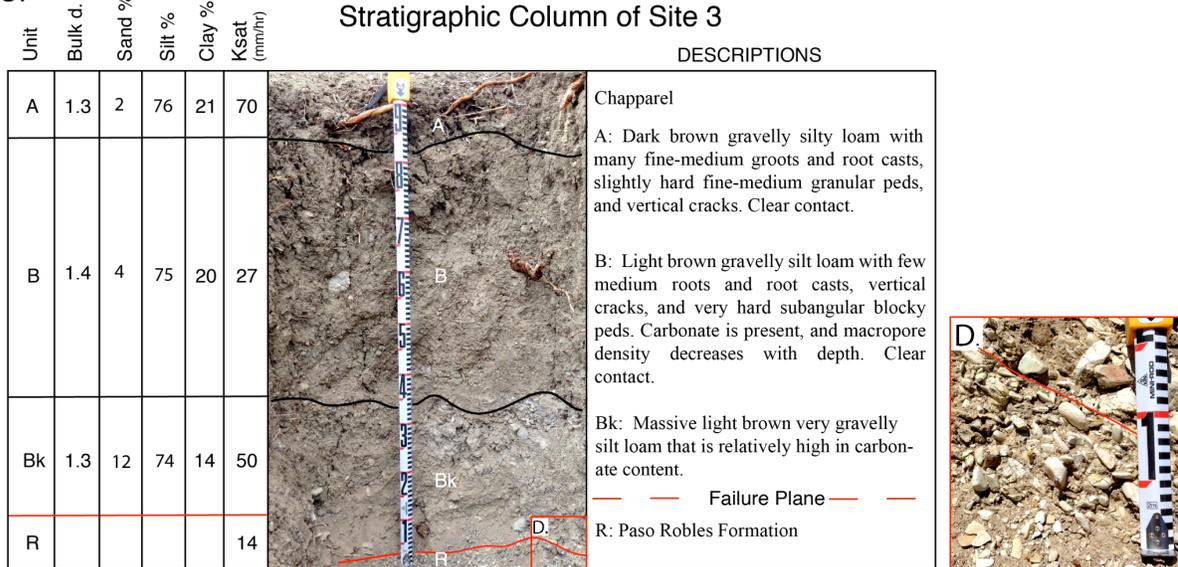
**Figure 8: Stratigraphic columns for sites 1, 2, and 3 with soil descriptions** Average values for particle size and bulk density for all pits and horizons are displayed in columns on the left. The failure plane is marked with a red dashed line. A) Site 1-pit 1. B) Site 2-pit 3 with. Notice at the soil-bedrock contact the weathering of the bedrock, that fractures are filled with overlying soils, and that below the contact, only bedrock exists. Fractures below the soil bedrock interface are open, allowing water to flow freely through them, thus increasing the saturated hydraulic conductivity. C) Site 3-pit 1 D) Paso Robles formation at the failure plane for site 3. Here, the soil-bedrock contact is marked by the infilling of interstitial spaces with overlying fine grained particles and calcium carbonate. Below this contact, small fractures and interstitial spaces are open, and less calcium carbonate exists.

that concentrates subsurface flow. The deepest section of the slide is found near the center of the headscarp. As you approach the lateral scarps and the toe of the landslide, soil depth decreases. The soils here are characterized by a thin 10-20 cm A horizon, followed by a 20-35 cm B horizon, and finally, a 8-12 cm Bt horizon (Figure 8a).

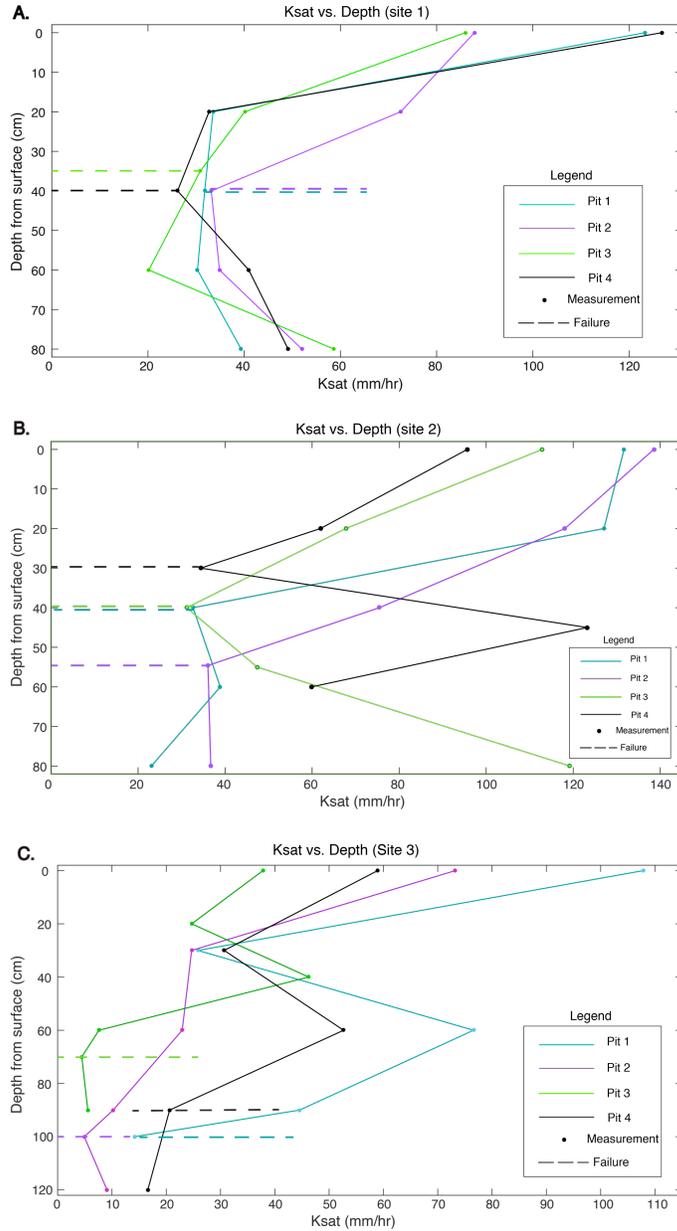
**Figure 9: Graph of  $K_{sat}$  vs. depth for sites 1, 2, and 3. A) Graph of  $K_{sat}$  vs. depth for site 1. Notice that all pits exhibit the pattern of fast infiltration at the surface, slowest infiltration at the failure plane, and increased infiltration below the failure plane (fast-slow-fast). The failure plane for each pit is denoted by a dashed line. B) Graph of  $K_{sat}$  vs. depth for site 2. Minimum values of  $K_{sat}$  are observed at the failure plane for 3 out of 4 pits.  $K_{sat}$  at pits 3 and 4 increases rapidly below the failure plane. Infiltration rate variability below the failure plane is attributed to bedrock fracture spacing, density, and amount of infilling from overlying soils. C) Graph of  $K_{sat}$  vs. depth for site 3. Slowest rates of infiltration are found at the failure plane. Notice the convergence and decrease in  $K_{sat}$  at 20-30 cm depth. This is attributed to an increase in clay content, compaction, or calcium carbonate at this horizon.**

The A horizon exhibits higher values for K<sub>sat</sub> than the B horizon on average. The largest contrast in K<sub>sat</sub> is between the A horizon and the failure plane. Mean K<sub>sat</sub> for the A horizon measurements for all three sites was found to be 94.6 mm/hr ± 7.6 mm/hr, whereas mean K<sub>sat</sub> measurements taken at the failure plane averaged 22.5 mm/hr ± 1.8 mm/hr. K<sub>sat</sub> measurements taken in the B horizons averaged 39.5 mm/hr ± 16.7 mm/hr, and K<sub>sat</sub> measurements taken below the failure plane average 44.4 mm/hr ± 8.7 mm/hr.

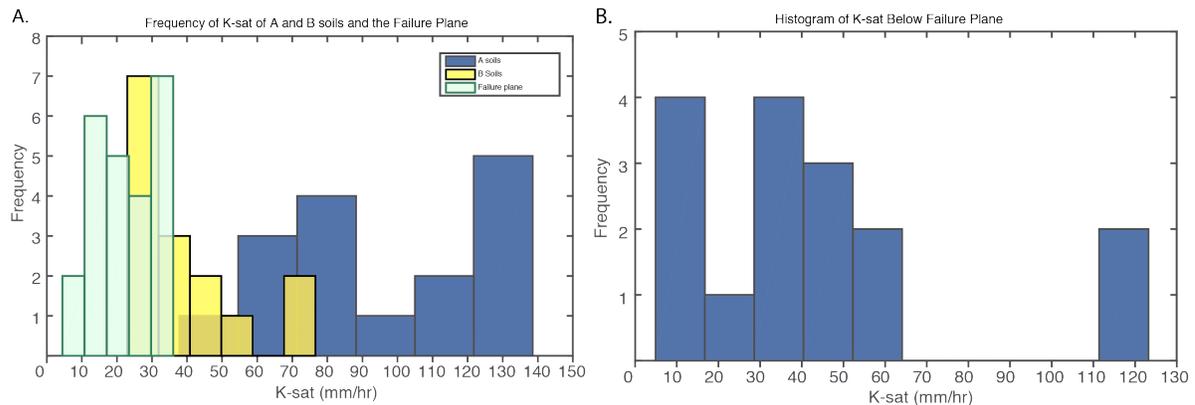
**Figure 10: A) Histograms showing the frequency and distribution of  $K_{sat}$  in the A and B horizons and the failure plane. Note that the failure plane and A horizon measurements do not overlap, and the differences in kurtosis and skewness between the horizons. The failure plane exhibits the most narrow range of values. B) Histogram of  $K_{sat}$  below the failure plane. Note that  $K_{sat}$  exhibits a wide distribution, overlapping with all other horizons and contains two peaks centered around 10 and 35 mm/hr, near the average values for the failure plane and B horizon.**

Histograms show the relative frequency and distribution of infiltration measurements in each group (Figures 10A and 10B). Soils from the A horizon exhibit the widest distribution, and range from 38-139 mm/hr, whereas  $K_{sat}$  at the failure plane are more tightly distributed and range from 4-33 mm/hr.  $K_{sat}$  values from the A horizon exhibit no overlap with the failure plane.  $K_{sat}$  values in the B horizon range from 25–77 mm/hr. A separate histogram shows the distribution of infiltration rates below the failure plane (figure 8b). With infiltration rates ranging from 5–123 mm/hr, bedrock below the failure plane exhibits a large range of values, overlaps with all other horizons, and contains two peaks centered around 10 and 35 mm/hr. The distribution of  $K_{sat}$  below the failure plane exhibits similar characteristics when compared to the B horizon and Failure plane distributions.

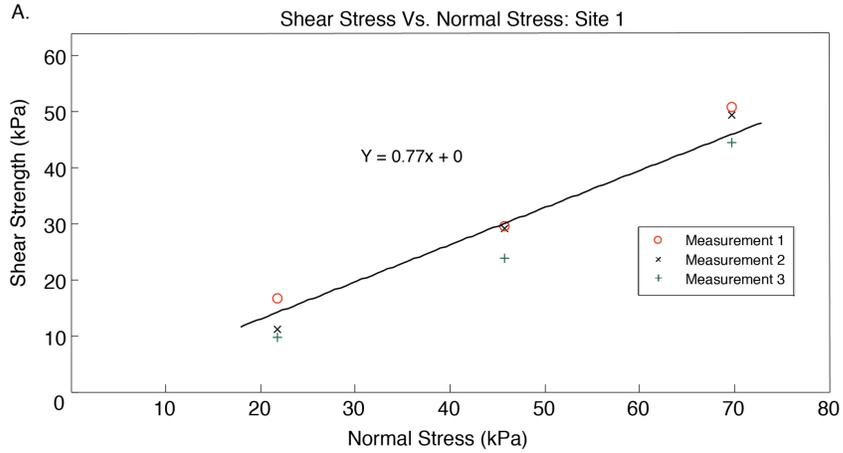
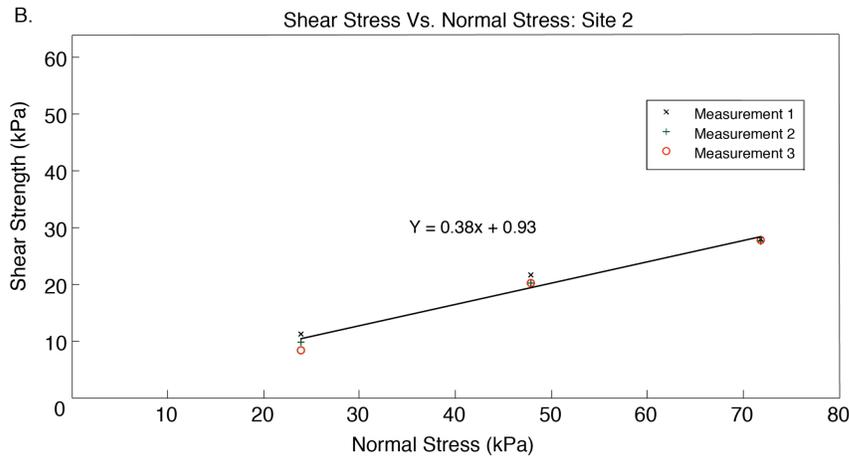
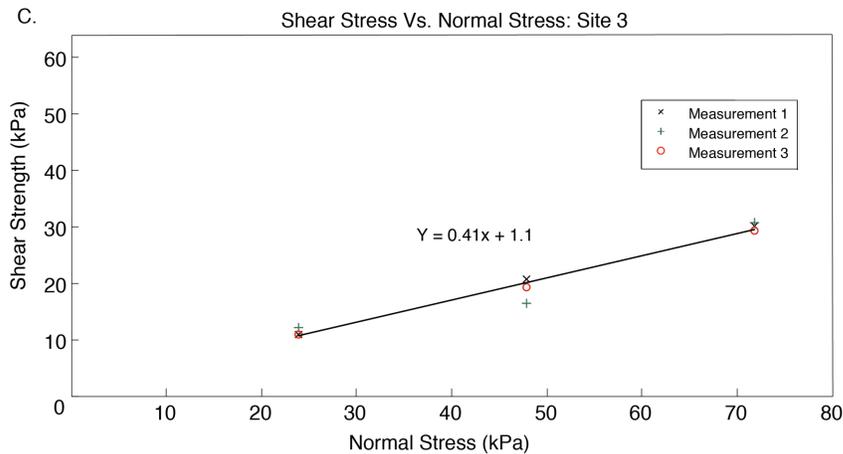
**Figure 11: A) Direct shear measurements for site 1. B) Direct shear measurements for site 2. C) Direct shear measurements for site 3. The OLS regression lines for the three separate tests are plotted on each graph. The equation of the OLS line that was used to calculate cohesion, and the internal angle of friction is also displayed. Tests were performed at Pacific Soils, Santa Barbara, Ca**

The results of the direct shear tests are provided in table 1. Figure 11 shows direct shear measurements with the best fit line and equation for the Mohr Coulomb fracture criteria for each site. Sites SR2 and SR3 both exhibit similar values for cohesion and angle of internal friction. Values for cohesion at SR2 and SR3 were found to be 0.93 and 1.08 kpa and the angle of internal friction was found to be 21° and 22°, respectively. Site 1 was found to be cohesionless and exhibited a higher internal friction angle of 34°. Values of cohesion for sites SR2 and SR3 are comparable to the value of 0.7 Kpa used by Gabet and Dunne (2002).
